**Flood Control Project Maintenance
Levee Inspections**

Maintenance Issue Types Only, Levee Inspection Report By Mile - Fall 2018

Merced Streams Group

Waterway	Bank	Unit Miles	Inspection Start/End	Inspector
Unit No. 01 Black Rascal Diversion	Right	1.61	10/23/2018 10/23/2018	Corey Fujitani

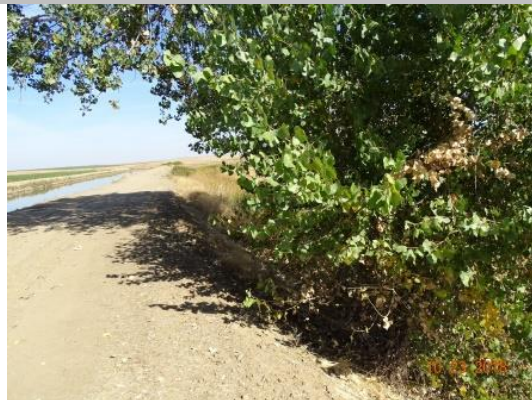
Photo 1 of 1 : FA_2018_NA0013_331_9_20181108_00012.jpg

trim tree limbs 5 feet above ground surface. (Fall 2018)

LM Start	1.54	Rating **	M	Issue No.	9
LM End	1.54	Issue Type +	Ma	Location *	WS
Category	Earthen Levee			GPS Latitude/Longitude	
				Start	End
Item	Trim / Thin Trees			37.336103°	37.336103°
				-120.396543°	-120.396543°
DWR ID	DWR_NA0013_01_s_2018_9				
Comment Code					
T1 : Trim trees to at least five feet above ground level.					
Inspector Comment

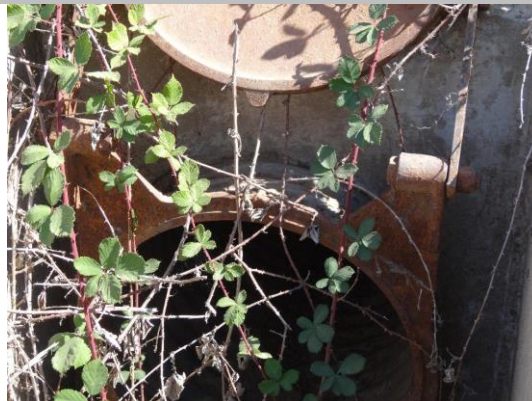
Photo 2 of 3 : UCIP_FA_2018_50156_35244.jpg

WS view: U typed concrete headwall, CM pipe, and flap gate. Flap gate was not closed. Vegetation needs to be cleared.

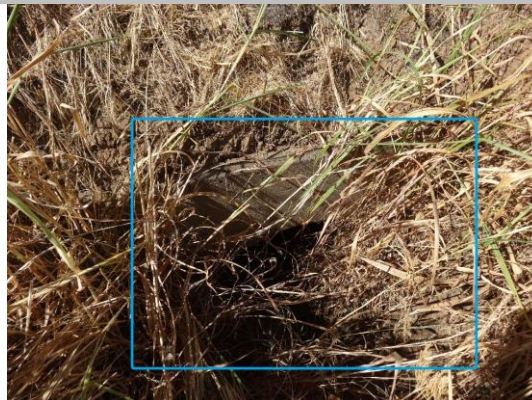
Photo 3 of 3 : UCIP_FA_2018_50156_35246.jpg

LS view: concrete headwall and CM pipe. Inlet needs cleaning.

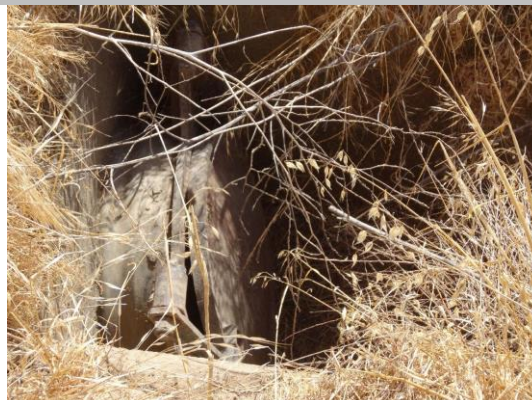
Photo 2 of 3 : UCIP_FA_2018_20946_35265.jpg

WS view: U typed concrete headwall, CM pipe, and flap gate. Flap gate was not properly closed.

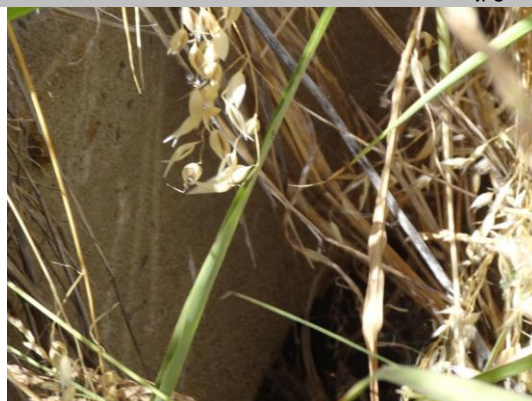
Photo 3 of 3 : UCIP_FA_2018_20946_35264.jpg

LS view: concrete headwall and CM pipe. Inlet needs cleaning.

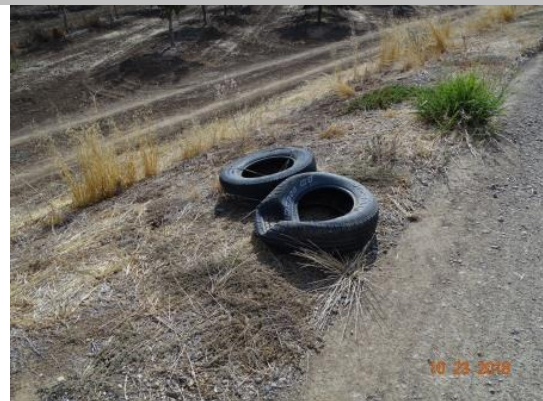
Photo 1 of 1 : FA_2018_NA0013_332_20_20181108_00039.jpg

Tires left on landside shoulder. (Fall 2018)

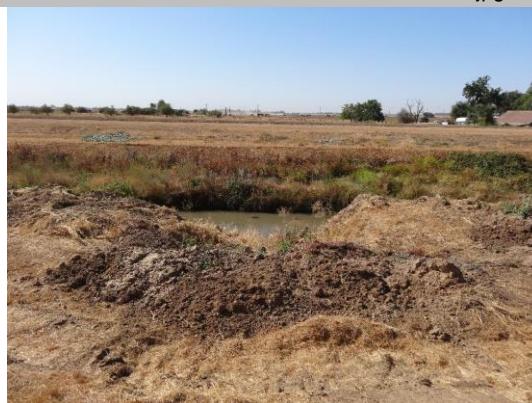
Photo 1 of 3 : UCIP_FA_2018_20992_35370.jpg

WS view: concrete headwall and CM pipe buried under debris and mud.

Comment Code						
Inspector Comment						
FS_ID:20992						
DS_ID:23055						
EP_NO: N/A						
Repair Type: Non-Urgent						
Crossing Status: Found						
UCIP Comments: 09/17/2013 - mud and debris from recent channel cleaning needs to be removed from spillway and outlet - pipe filled with debris, it needs cleaning.- half of intet pipe burried. (DWR UCIP - P. Amatya)						
FIELD_STRUCT_DESC: 24-inch corrugated metal gravity drainage pipe through the levee, 8 feet below the crown. Concrete headwall, flap gate, and concrete grouted cobble spillway on the waterside (WS) toe.						
Concrete headwall on the landside (LS) toe. [Additional Reference(s): DWR Levee Log, 2005. USACE San Joaquin O&M Manual 607, June 1962, (HLM 0.73)].						
FS Date: 9/17/2013

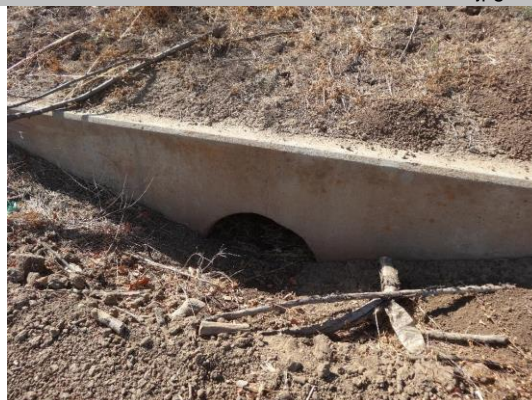
Photo 3 of 3 : UCIP_FA_2018_20992_35366.jpg

LS view: concrete headwall and CM pipe. Half of intet pipe burried.

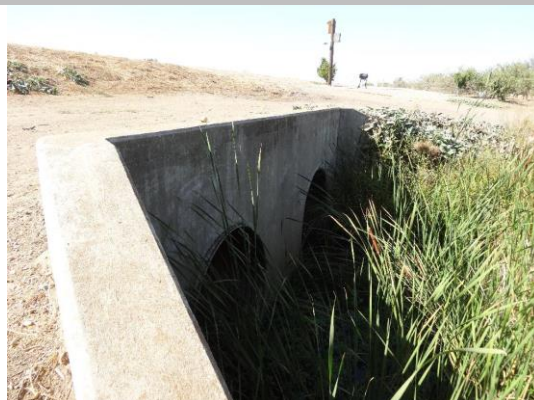
Photo 2 of 3 : UCIP_FA_2018_20983_35301.jpg

LS view: U typed concrete headwall, two CMPs in drainage ditch. Dense vegetation in drainage ditch.

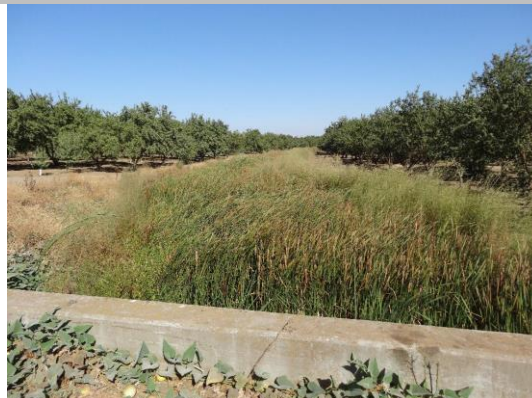
Photo 3 of 3 : UCIP_FA_2018_20983_35300.jpg

LS view: concrete headwall in drainage ditch. Dense vegetation in drainage ditch.

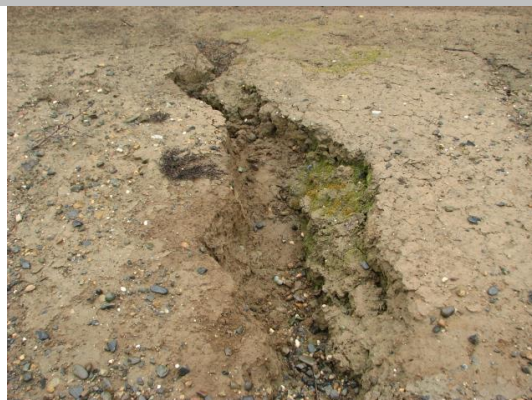
Photo 1 of 3 : FA_2018_NA0013_332_15_20180905_00005.jpg

Looking east at finger erosion on landward slope. (Spring 2018)

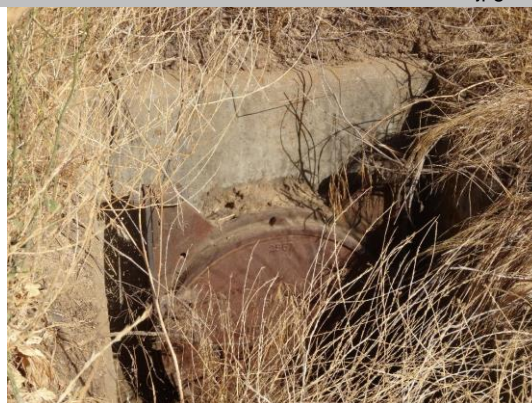
Photo 2 of 3 : UCIP_FA_2018_42993_35309.jpg

WS view: U typed concrete headwall, CM pipe and flap gate. Vegetation and debris need to be cleared.

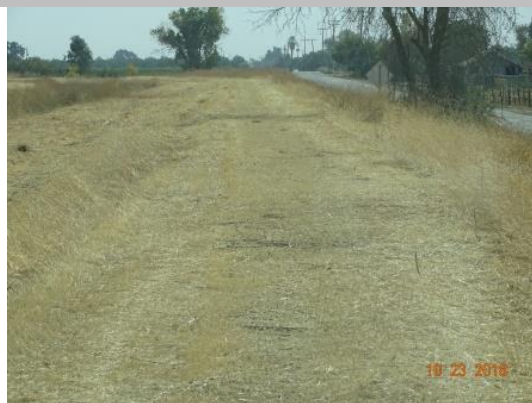
Photo 1 of 2 : FA_2018_NA0013_333_10_20181108_00033.jpg

Tall grass on landside slope. (Fall 2018)

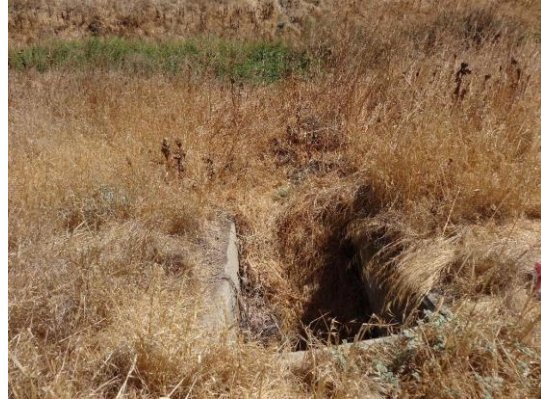
Photo 2 of 3 : UCIP_FA_2018_41815_35532.jpg

WS view: Silt needs to be removed. Vegetations needs to be cleared.

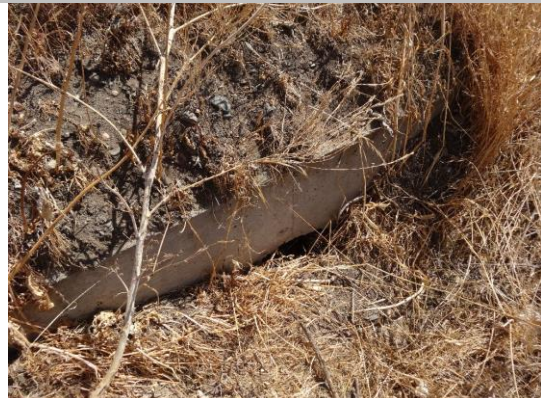
Photo 3 of 3 : UCIP_FA_2018_41815_35531.jpg

LS view: concrete headwall and CM pipe. Inlet needs cleaning and silt removed.

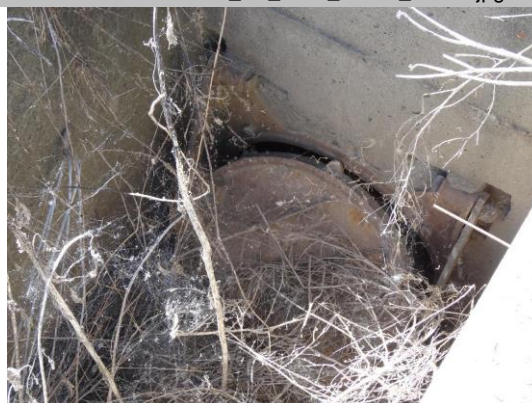
Photo 2 of 3 : UCIP_FA_2018_50144_35421.jpg

WS view: U typed concrete headwall, CM pipe, and flap gate. Damaged flap gate.

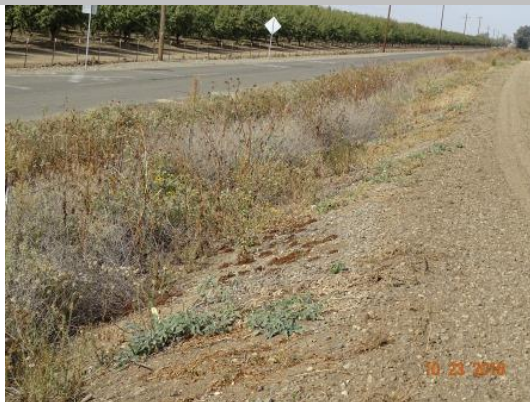
Photo 1 of 1 : FA_2018_NA0013_333_14_20181108_00031.jpg

Dense vegetation at landside toe. (Fall 2018)

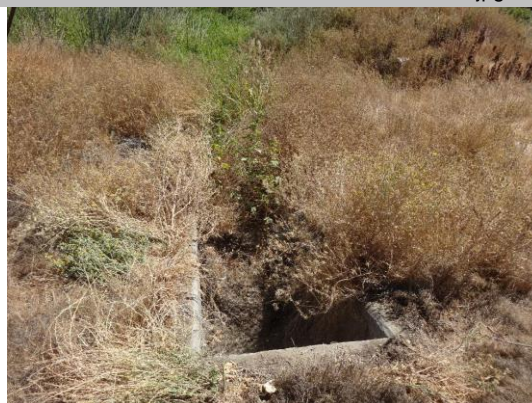
Photo 1 of 3 : UCIP_FA_2018_50149_35535.jpg

WS view: cobble spillway and channel on waterside. Dense vegetation on levee slope.

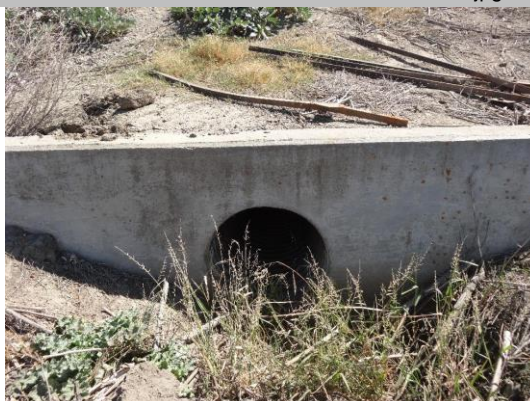
Photo 3 of 3 : UCIP_FA_2018_50149_35537.jpg

LS view: concrete headwall and CM pipe. Inlet needs clearing.

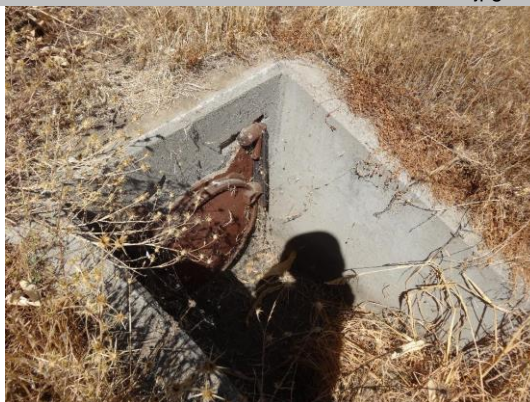
Photo 2 of 3 : UCIP_FA_2018_50151_35538.jpg

WS view: U typed concrete headwall, CM pipe, and flap gate. Vegetation needs to be cleared.

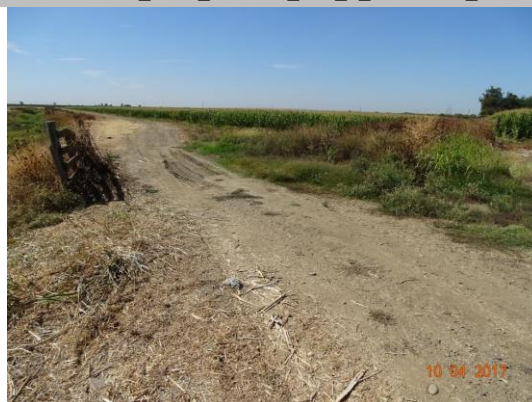
Photo 1 of 1 : FA_2018_NA0013_333_9_20180905_00001.jpg

Repair rutted crossing over storm drain. Restore grade and add gravel.

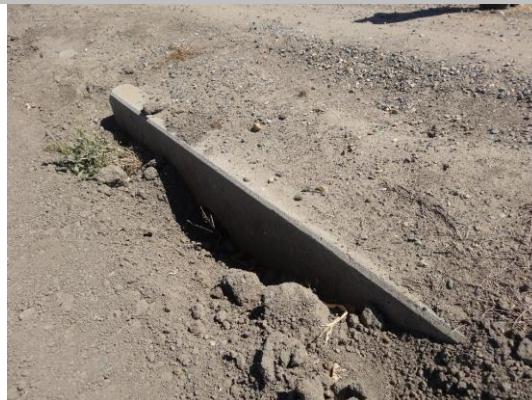
Photo 3 of 3 : UCIP_FA_2018_50152_35542.jpg

LS view: concrete headwall and CM pipe. Inlet needs clearing & cleaning.

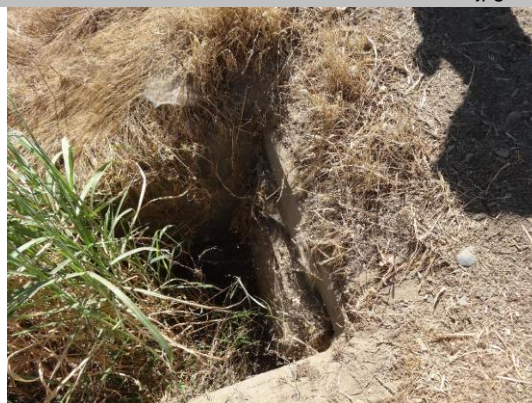
Photo 2 of 3 : UCIP_FA_2018_21064_35505.jpg

WS view: U typed concrete headwall, CM pipe, and flap gate. Vegetation needs to be cleared.

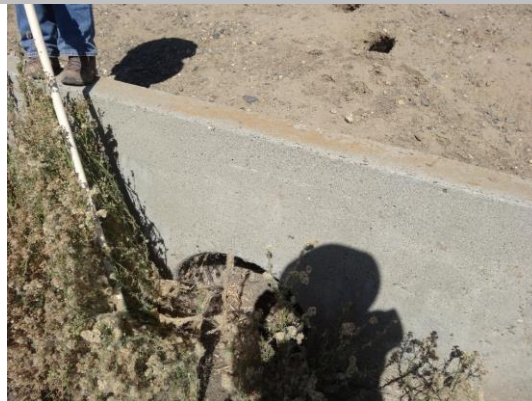
Photo 2 of 3 : UCIP_FA_2018_50146_35747.jpg

LS view: concrete headwall and CM pipe. Inlet needs clearing.

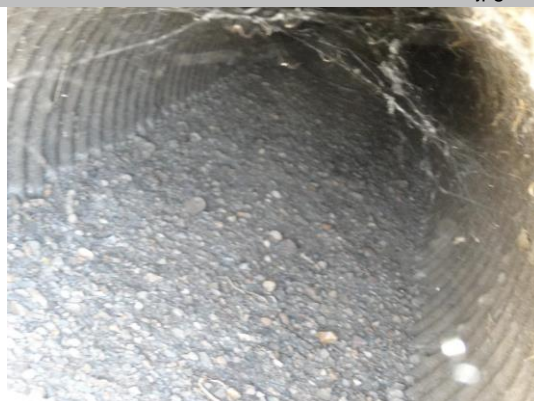
Photo 3 of 3 : UCIP_FA_2018_50146_35746.jpg

LS view: inside view of CM pipe. Inlet pipe needs clearing.

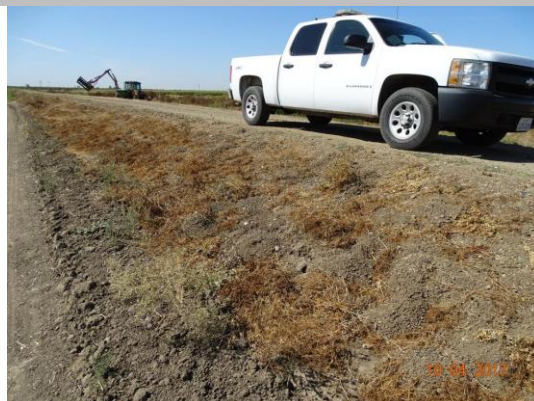
Photo 1 of 1 : FA_2018_NA0013_334_10_20180905_00001.jpg

Numerous rodent holes on LS slope.

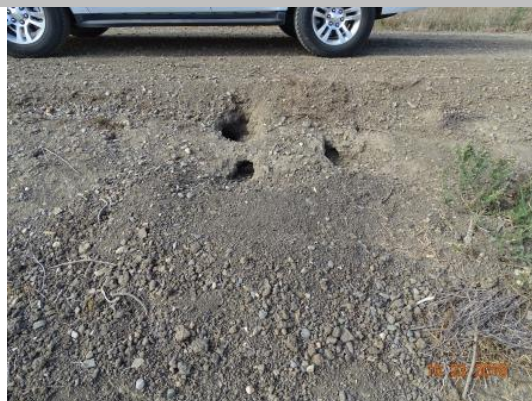
Photo 1 of 1 : FA_2018_NA0013_334_16_20181108_00034.jpg

View of rodent holes in landside slope. (Fall 2018)

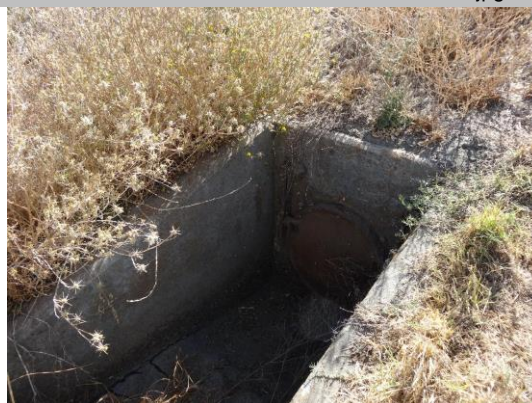
Photo 2 of 3 : UCIP_FA_2018_50154_35607.jpg

WS view: U typed concrete headwall, CM pipe, and flap gate. Vegetation needs to be cleared on spillway.

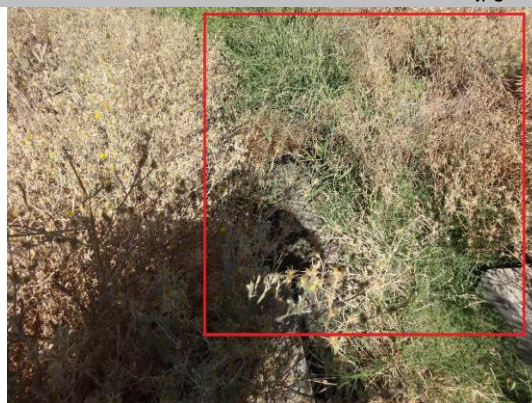
Photo 1 of 3 : UCIP_FA_2018_50148_35613.jpg

WS view: Dense vegetation on levee slope and spillway.

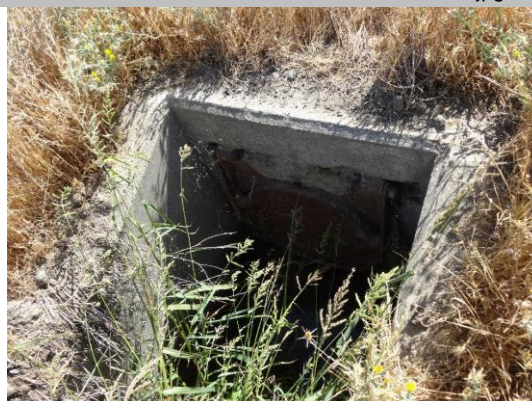
Photo 2 of 3 : UCIP_FA_2018_50155_35641.jpg

WS view: U typed concrete headwall, CM pipe, and flap gate. Vegetation needs to be cleared.

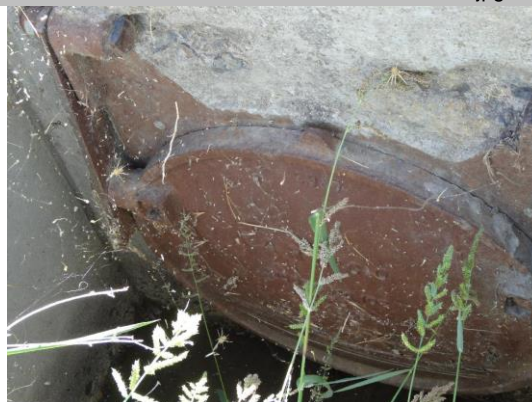
Photo 3 of 3 : UCIP_FA_2018_50155_35640.jpg

WS view: CM pipe and flap gate. Vegetation needs to be cleared.

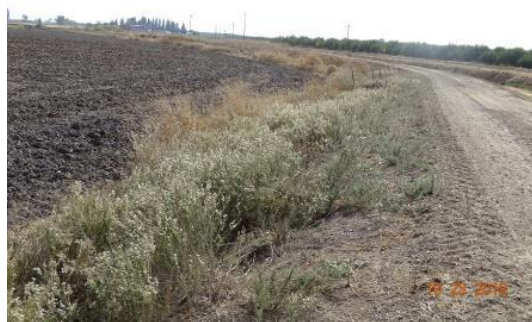
Photo 1 of 1 : FA_2018_NA0013_334_19_20181108_00035.jpg

dense vegetation on landside slope. (Fall 2018)

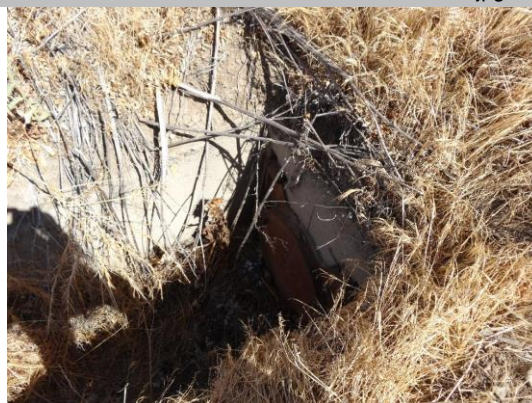
Photo 1 of 3 : UCIP_FA_2018_52888_35709.jpg

WS view: concrete spillway and channel on waterside. Dense vegetation on levee slope and spillway.

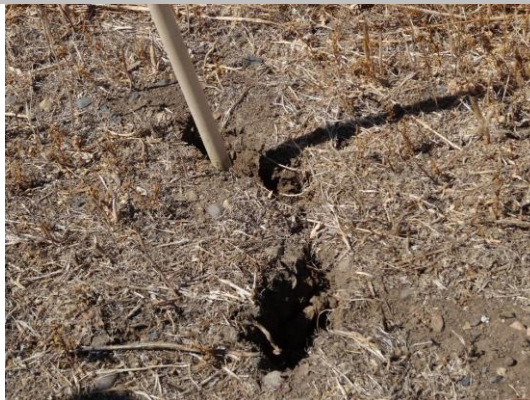
Photo 2 of 3 : UCIP_FA_2018_50153_35744.jpg

WS view: significant levee cracks along the pipe alignment. Needs detailed investigation on the issue.
